# Partial Discharge Report

Snapshots 2

Minimum level 13.2 dB Maximum level 14.5 dB

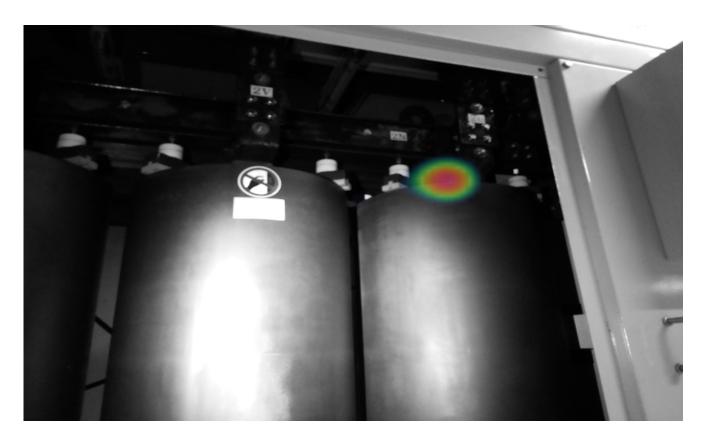
This is classified as a surface or internal discharge. The discharge appears to be strong and might rapidly escalate to complete insulation breakdown.

Level	13.2 dB
Created date	14.8.2020
Device	AC130033
Device Label	AC130033_00138_200814_1 037_0138
Distance	1 m
Voltage	
Location	transformer

Immediate action. Visual inspection. Cleaning of polluted surfaces. Repair or replacement of the components.

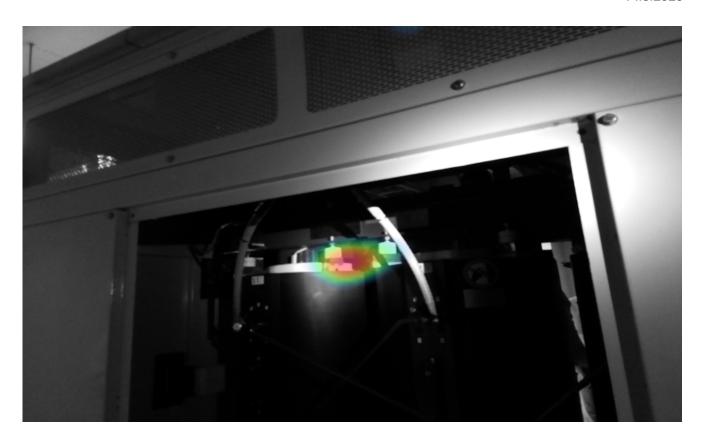
This is classified as a surface or internal discharge. The discharge appears to be strong and might rapidly escalate to complete insulation breakdown.

Level	14.5 dB
Created date	14.8.2020
Device	AC130033
Device Label	AC130033_00139_200814_1 045_0139
Distance	1 m
Voltage	
Location	transformer

Immediate action. Visual inspection. Cleaning of polluted surfaces. Repair or replacement of the components.
